Manhole Inspection Summary

Manhole # S11KK_002MH

Insp Date: **7/10/08 10:00 AM**

Location Address: **3045 WALBROOK AVE**

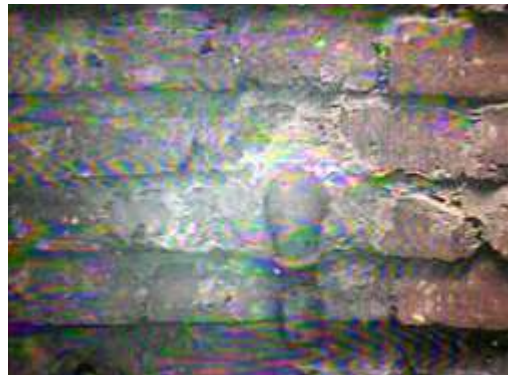
Defect 1

POSSIBLE ILLICIT CONNECTION.

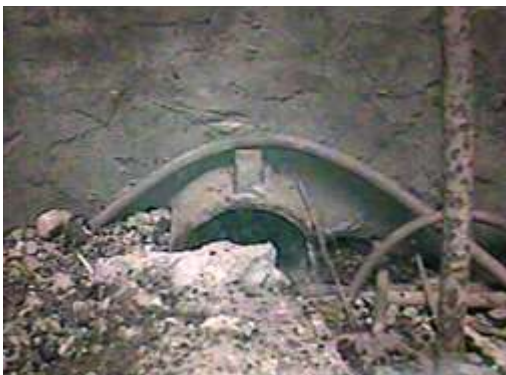
Defect 3

Condition: ☐ Sound ☐ Cracked ☐ Root Intrusion ☐ Deteriorated ☐ Leaks ☒ **Debris**

DEBRIS IN CHANNEL

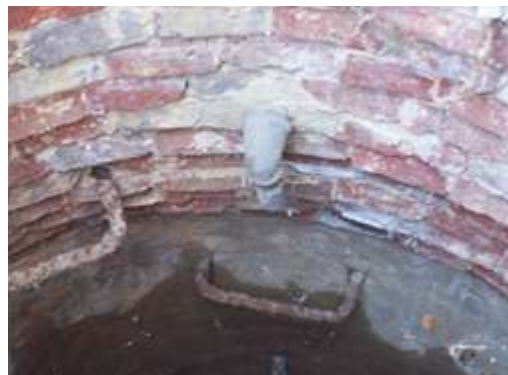
Defect 2

Steps Count: **3** Missing: **1** ☒ **Corroded**

ILLICIT CONNECTION. CORRODED STEPS.

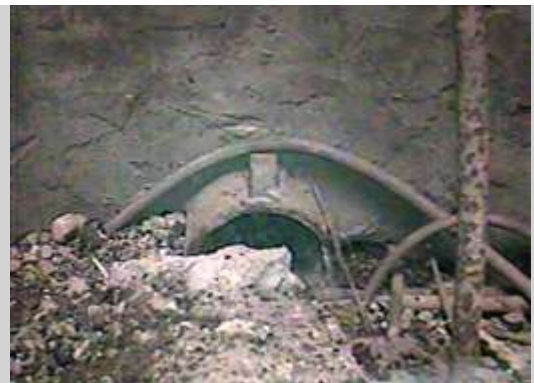
12 O'Clock Outflow

DEBRIS.

☒ **Possible Illicit Connection**
